MASSACHUSETTS COASTAL BASIN
GLOUCESTER, MASSACHUSETTS

WEST POND OUTLET
MA 00186

**PHASE I INSPECTION REPORT
NATIONAL DAM INSPECTION PROGRAM**

DECEMBER 1979

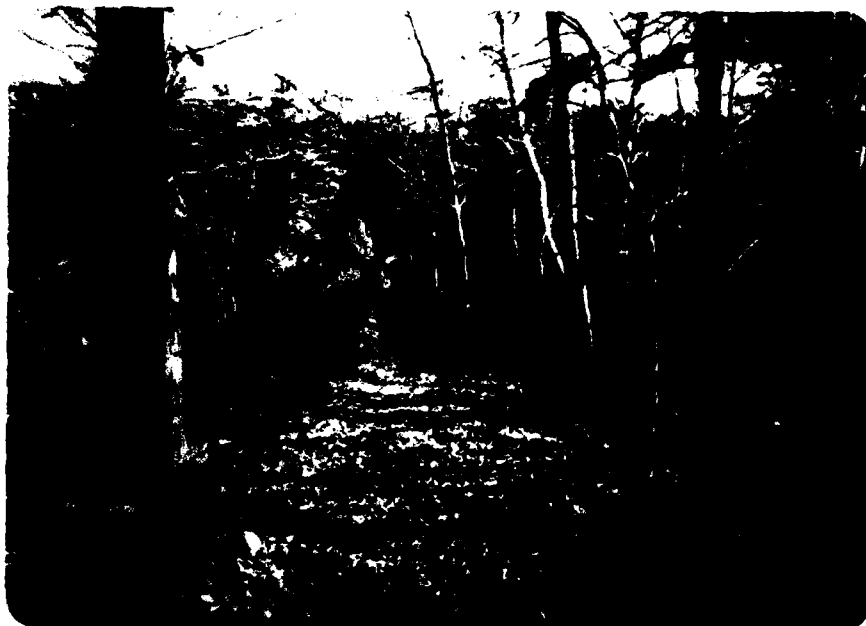
- b. Dam. West Pond Outlet is a earthfill dam with a stone masonry core wall. It was found to be in poor condition, a condition that has been prevalent since the first recorded inspection in 1912. The top of the dam is extremely narrow and footpaths have been heavily worn on the crest. In one place erosion of the top has occurred indicating the dam has been overtopped (see photographs 3 and 4 in Appendix C). The upstream slope is nearly vertical and the downstream slope is steep (1-1/2:1 horizontal to vertical). The upstream slope has been eroded exposing the core wall. Considerable sloughing was noted on both slopes. The riprap on the upstream slope has been eroded. Past inspection reports state that the riprap formerly on the upstream slope began to slide into the pond in 1938. Both slopes are covered with a thick growth of brush and trees (see photographs 1 and 2 in Appendix C).

NO. 1 VIEW EASTWARD ALONG TOP OF DAM
